Miljala Tributary Restoration Project Update: November

REA Recommendation!

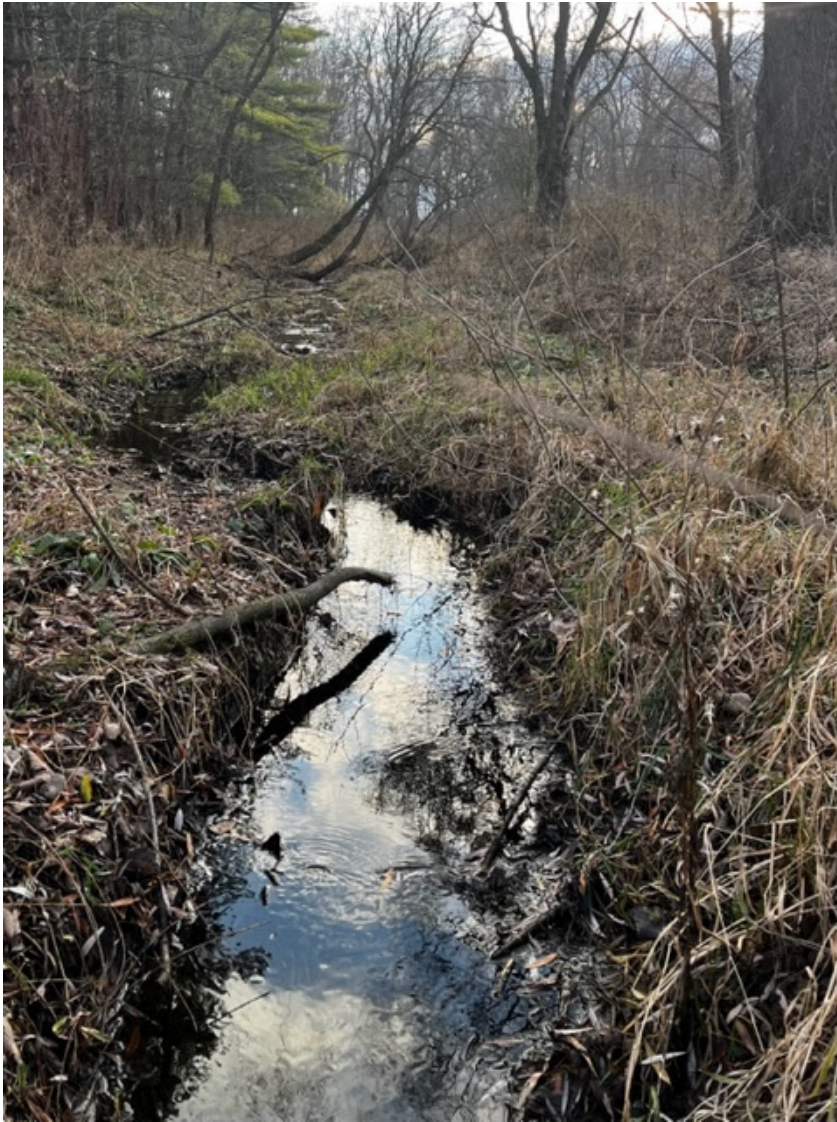
Miljala Tributary, late November 2022

Visual, topographic, and academic literature all indicate that the banks on the western and central area of the Miljala Tributary will continue to erode without intervention. They will erode until they reach a stable slope angle to maintain a low flow channel or until the area returns to a wetland (e.g., the banks fill in the low flow

channel and the area is saturated). The sediment that erodes from the banks during this process will flow into the Channel or deposit along the bottom of the tributary.

Consequently, REA recommends:

- Installing a two-stage design
- Shifting the project area by moving the focus of the project westward (away from Cedar Lane)
- Installing riprap at some locations to add greater stability
- Doing the construction in winter to limit erosion and maximize contractor availability
- Follow-on steps for the next phase
