Rock Lake Shorelands and Shallows Survey

Shorelands and Shallows Survey Protocols

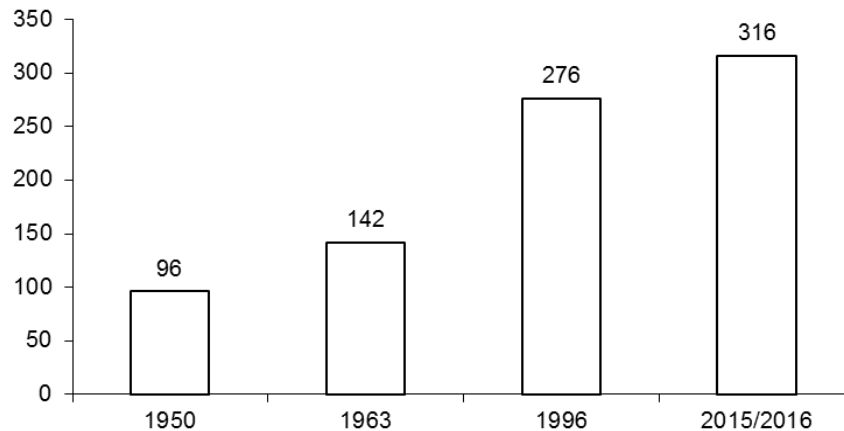
Number of Piers on Rock Lake (not including Marsh Lake, millpond, or Elm Point channel)

Throughout the years, there have been surveys of piers on Rock Lake. This number is important because it gives an indication of the development of the near-shore water area. The information is contained in the chart below. The 1950 and 1963 data was generated by the Department of Natural Resources (DNR) via mid-summer aerial photos. The DNR also did a pier survey by boat in 1996. These 3 surveys didn’t include piers in the millpond, Marsh Lake, or the channel located along Elm Point Road. The number of piers displayed in the chart for 2015/2016 includes the piers counted on Rock Lake (not the Marsh, millpond, or Elm Point channel). The number of piers documented in 2015 and 2016 in the Elm Point channel was 3 and in the millpond was 13. Properties that don’t have piers in the Elm Point channel still have boats that are parked along their frontage. In 2015/2016, the total number of piers on Rock Lake, the millpond, and the Elm Point channel was 332.
