Rock Lake Shorelands and Shallows Survey Results

Shorelands and Shallows Survey Protocols

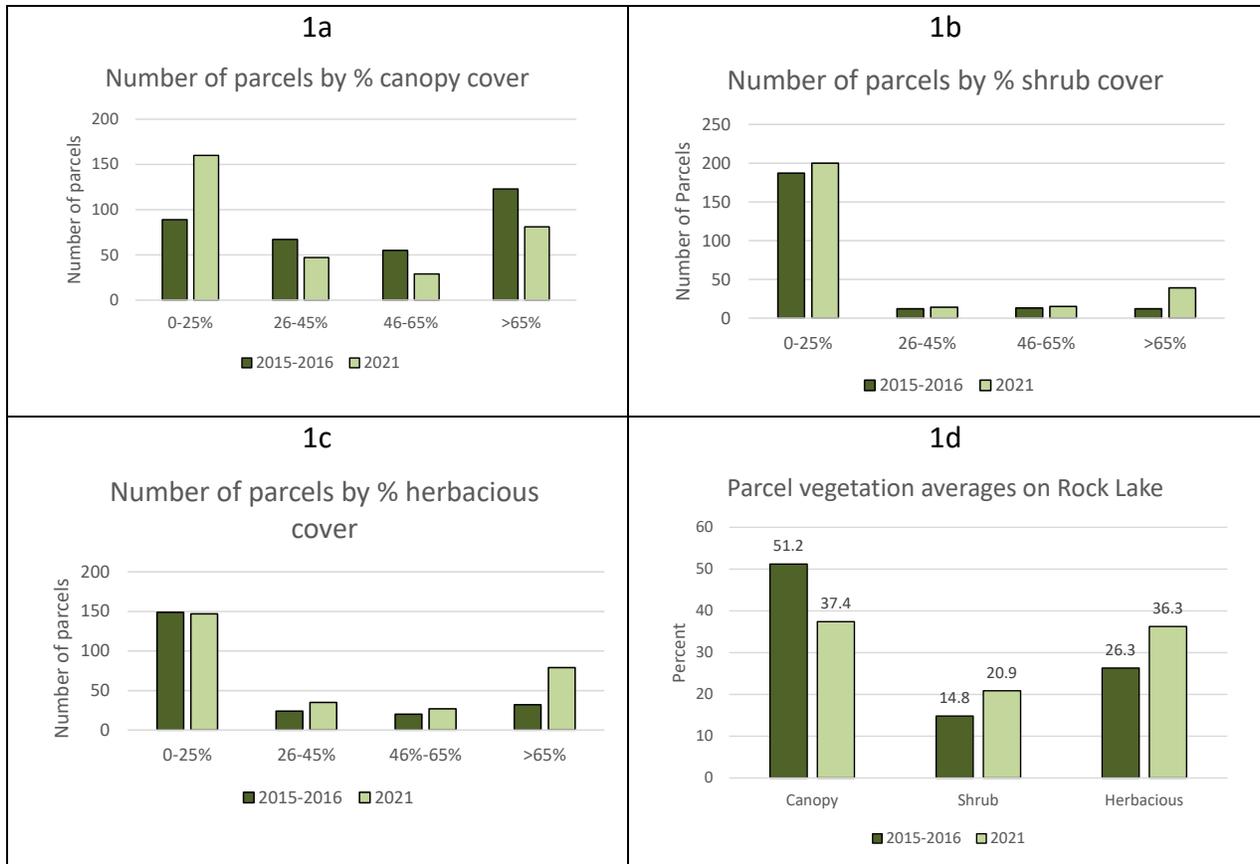
Figure 1a: Number of parcels on Rock Lake in each of four ranges of vegetation cover by the canopy from 0-25%, 26-45%, 46-65%, and greater than 65% thus meeting the current zoning standards.

Figure 1b: Number of parcels on Rock Lake in four ranges of vegetation cover for the shrub layer.

Figure 1c: Number of parcels on Rock Lake in four ranges of vegetation cover for the herbaceous layer.

Figure 1d: Average percent cover in the riparian zone of each habitat layer of parcels on Rock lake during the 2015-2016 and 2021 surveys.

Shorelands that were reported as having $\geq 65\%$ cover of shrubs and herbaceous plants in the riparian zone are the parcels that meet or exceed the state and county standard. The survey revealed that out of 341 tax parcels in 2015-2016, Rock Lake had 64 parcels that meet the state/county standard. Therefore only 18.7% of parcels meet the state standards for protecting the water quality of Rock Lake. In 2021 there were 83 parcels with $\geq 65\%$ shrub and herbaceous cover in the riparian zone, there were also two new parcels for a total of 343 tax parcels around Rock Lake resulting in 24.2% of parcels currently meeting the best practice standards for vegetated buffers. The two new parcels resulted from a larger multi dwelling former resort property splitting.

The vegetation in the riparian zone was assessed in three layers and characterized as natural or disturbed. The first layer whose cover was estimate was canopy. Canopy cover was the area of the riparian zone cover by tree canopies above 16ft. The second layer estimated is shrub cover, this layer includes woody vegetation below 16ft in height. The final layer of vegetation assessed is the herbaceous layer which includes non-woody plants. For the purposes of this survey there was not a distinction made between native, ornamental, or invasive vegetation in percent cover estimates. Vegetation was assessed individually in these three distinct layers because of the different habitat types and benefits they provide. During the 2015-2016 survey parcels with any evidence of human impact were assessed as 100% disturbed. In the 2021 survey, area of disturbance within the riparian zone was estimated on a parcel by parcel basis.

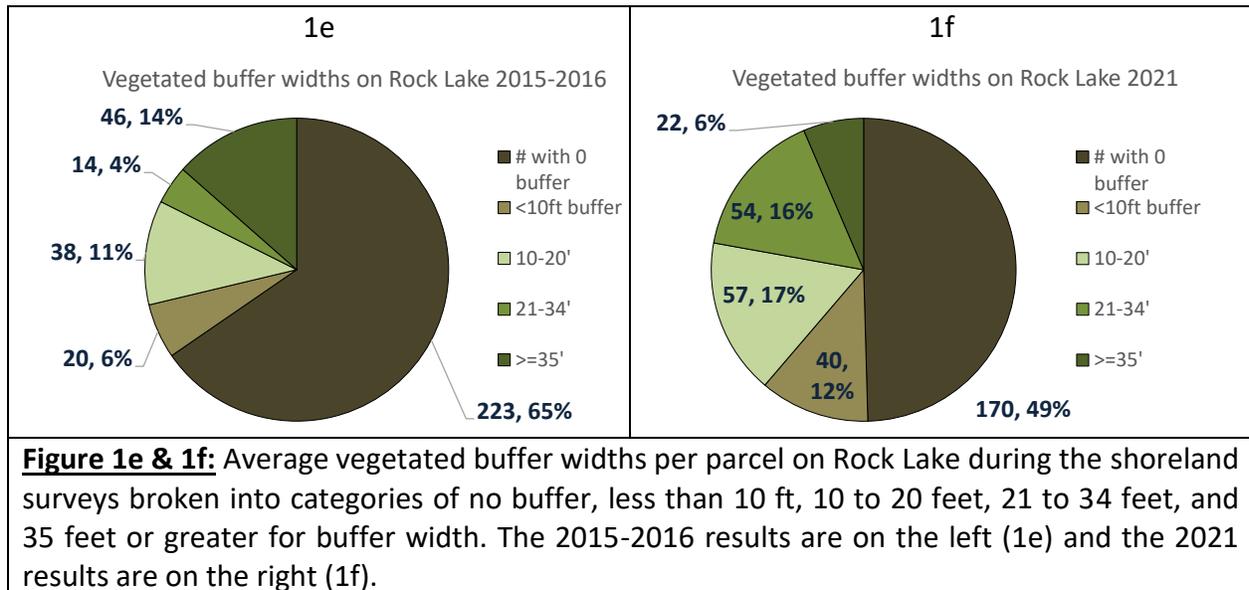
One additional parameter that was considered as a part of this survey on Rock Lake was the average vegetated buffer width of each parcel. This metric is not included in the official protocol but because of the importance of the native vegetation buffer in protecting the lake's water quality and providing habitat, its average width was estimated on Rock Lake by surveyors in both the 2015-2016 survey and the 2021 survey. There are also vegetated buffer goals outlined in the Rock Lake Management Plan and these data will help us assess our progress in reaching those goals. The number of parcels with vegetated buffers was found to have increased in 2021 from the previous survey. The average buffer width of Rock Lake in 2015-2016 was 7.7 feet and in 2021 it increased to 9.8 feet. Presently about half of the parcels on Rock Lake have some amount of vegetated buffer as compared to only 35% of parcels in 2015-2016. Although there has been an increase in the presence of buffers, there was a decrease in fully vegetated riparian areas (those with an average buffer of 35 or greater). This estimate considers the vegetation only within the riparian zone meaning 35 feet was the maximum buffer width possible. This parcel would be completely or nearly completely vegetated (if there was only a path, trail, or stairs to the water the parcel was typically given an average of 35). This increase in vegetated buffers on Rock Lake supports the finding that there was greater shrub and herbaceous cover in the riparian zone during the 2021 survey.

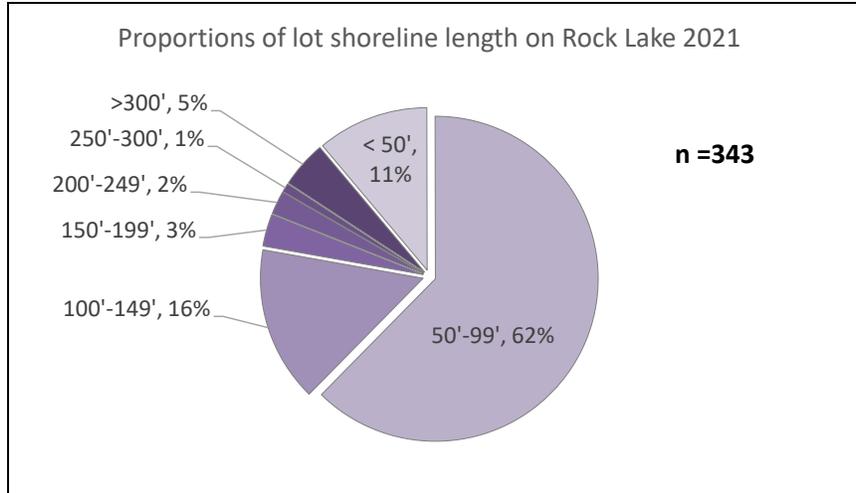
Figure 1g: Rock Lake lot length proportions of total shoreline

Another way to judge the amount of vegetated buffer on Rock Lake is to look at the total length of shoreline that meets the standard. During the 2015-2016 survey there were about 1.93 miles of shoreline that had $\geq 65\%$ shrubs and/or herbaceous plants in the riparian zone. Therefore, 26.4% of the shoreline meets the standard. During the 2021 survey it was found that 2.39

miles of shoreline contained $\geq 65\%$ shrubs and/or herbaceous plants in the riparian zone for a total of 33.1% of the total shoreline of Rock Lake. While about one fifth of the shoreline has the ideal presence of vegetated buffer we can see in figure 1f that nearly two thirds of the 343 parcels on the shoreline of Rock Lake consist of parcels that are between 50 and 99 feet in shoreline length. During the 2015-2016 survey only 30 of the parcels that had $\geq 65\%$ shrub and herbaceous plants in the riparian zone were in the 50'-99' lot length range, in 2021 this number rose to 46. The presence of a healthy vegetated buffer on Rock Lake can be greatly improved by individual landowners taking action on their own properties

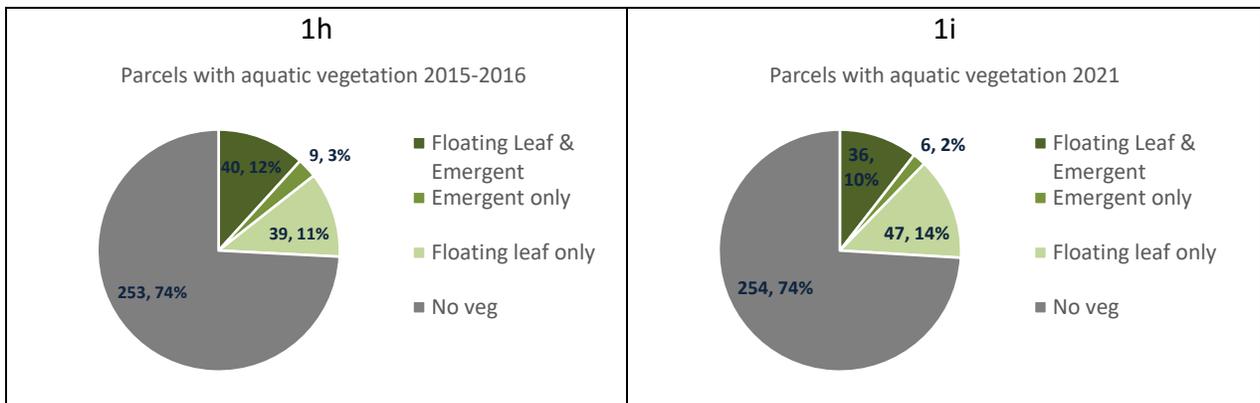
Figure 1h: Presence of emergent and floating leaf vegetation immediately in front of parcels on Rock Lake during the 2015-2016 survey.

Figure 1i: Presence of emergent and floating leaf vegetation immediately in front of parcels on Rock Lake during the 2015-2016 survey.

Presence or absence of emergent, floating leaf, and submerged aquatic plants were noted in front of each parcel during the survey if those plants occurred within fifty feet of the shoreline. The presence of submerged aquatic plants was noted when they were seen, however the conditions were not always conducive to seeing the submerged plants. Distance from shore also makes it more difficult to view submerged plants due to glare on the surface and color and

clarity of the water. For that reason, only the emergent and floating leaf vegetation presence is included in the figures 1g and 1h above and the ‘no veg’ category means that there was not floating leaf or emergent vegetation present but there could have been submerged. To better understand the health of the entire plant community, the aquatic plant survey results in the current lake management plan should be referenced. The number of parcels that had either floating leaf, emergent or both growth types of vegetation present was nearly identical between the two surveys. There was a small shift in proportion between surveys with the amount of floating leaf vegetation increasing while the emergent growth type minorly subsided. As with the health and presence of the submerged plant community, the true health and extent of the floating leaf and emergent plant communities would be more accurately defined in the whole lake aquatic plant survey; but these data show us that their presence directly in front of parcels has not changed much between surveys and may indicate that there is not widespread removal of those vegetation types occurring on Rock Lake. The reason for the documentation of these data in the shoreland survey is to help capture any human impacts to the natural state of the lake including removal of vegetation that may be occurring. Riparian landowners are allowed to manually rake aquatic plants from a 30-foot-wide corridor in front of their property to provide access to the lake for swimming and navigation. The full details of this permit exemption can be found in state statute NR 109.

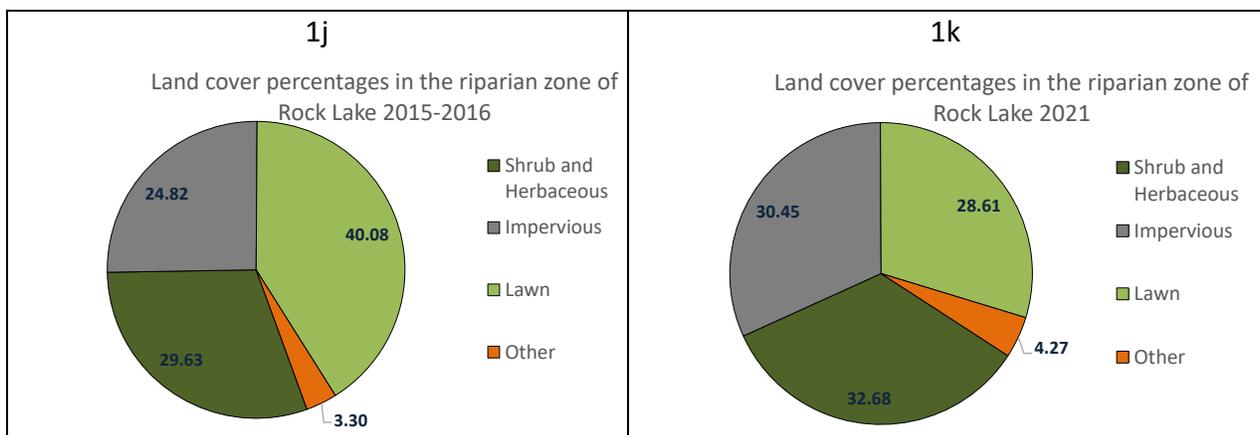
Figure 1j: Land cover in the riparian zone during the 2015-2016 shoreland survey by land use type.

Figure 1k: Land cover in the riparian zone during the 2021 shoreland survey by land use type.

The percent of land cover types found within the riparian zone was estimated for each parcel. The information recorded for all of the parcels is summarized in the pie charts above. The “other” component included bare soil, sand, gravel, cobble, and mulch. The results of the land cover types in the riparian zone, like other metrics, also show that the area covered by shrub and herbaceous vegetation has indeed increased since 2015-2016 but it also shows how that land cover has shifted in other ways. While there was an increase in riparian area occupied by shrub and herbaceous vegetation in 2021 we can see in figures 1j and 1k that there was also an increase in the amount of impervious area in the riparian zone on Rock Lake. The percentage of area in the “other” category remained similar between surveys so it is clear from the decrease in the percentage of area covered by lawn that much of the area that was occupied by

manicured lawns in 2015-2016 was shifted to other covers. The data indicates that since the 2015-2016 surveys about 11% of the riparian area on Rock Lake has been converted from lawn to either shrub and herbaceous habitat area or areas of impervious surface in 2021.

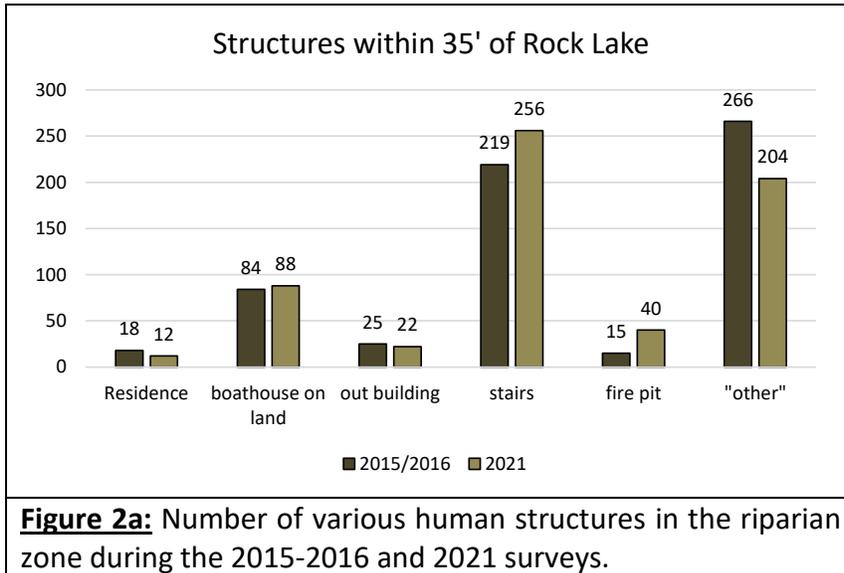
The number of structures within 35 feet of the ordinary high water mark (OHWM) were counted as part of the survey. Structures in the “other” category included items such as paths, retaining walls, decks, patios, boats on shore, fishing platforms and roads. During this survey structures presence in the riparian zone was determined using a range

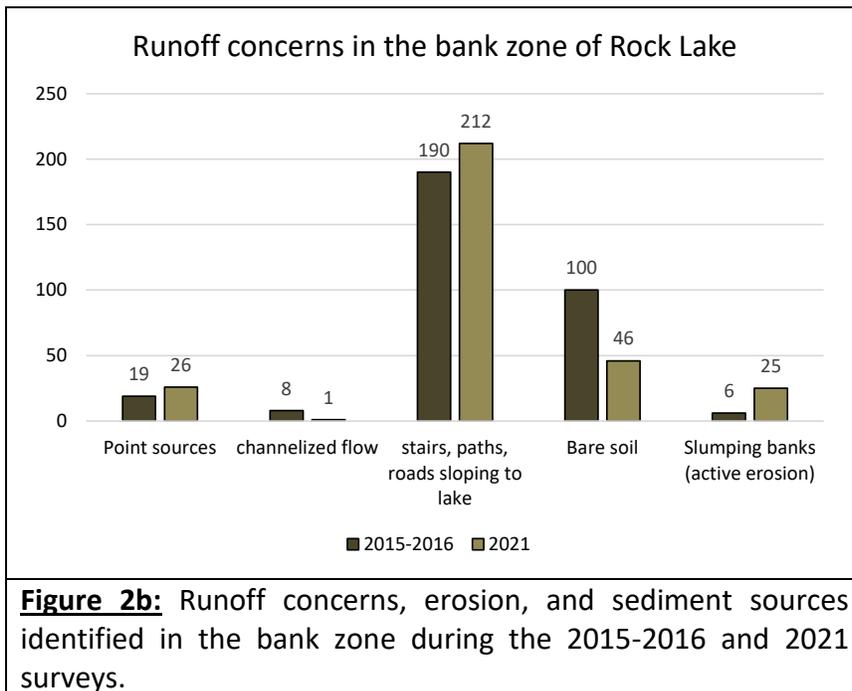
Run off concerns were also documented during the survey. These occurrences were documented both in and outside of the riparian zone. These concerns were documented individually because most of them could be considered a direct source of pollution to the lake. Stairs, paths, and roads sloping to the lake can create a direct path for water to quickly enter the lake during runoff events. There was a slight increase of these items in the riparian zone between surveys.

Bank modifications documented as part of this survey include vertical seawall, rip rap, artificial beach, and an “other erosion control” category. Due to their numerous negative impacts on nearshore habitat, new seawall installation is very rare in Wisconsin and in most cases will not be permitted. There is however still some opportunity to replace existing seawall that may be failing. While still having impacts to habitat and aquatic organism life cycles, rip rap has fewer negative impacts. New rip rap can still be installed on lake shores and in some cases is exempt from requiring a permit. The length and presence of these types of erosion control is noted in the shoreland survey due to their impact on aquatic and near shore habitat. Since the lengths are estimated, there can be some difference in the numbers from year to year that stems from human error rather than a true shift in the amount of erosion control structures on the lake. While the results of the 2021 survey showed a small decrease in the amount of seawall on Rock Lake, it is likely that this difference is a result of estimation differences from observers between surveys. We know that new seawall is extremely unlikely to be permitted and that seawall removal is an uncommon practice so the most reasonable conclusion from the survey data is that the amount of seawall on Rock Lake has remained essentially the same between surveys. The presence of rip rap also showed a decrease in 2021 from the 2015-2016. In 2021 there were three fewer parcels with rip rap than in 2015-2016. The difference in shoreline length of rip rap seems to indicate a greater change but this also is most likely due to differences in estimation. Another consideration that should be noted is that if there was failing rip rap that was no longer functioning to prevent erosion, it was not counted as rip rap during the survey and this could be the reason for the three fewer parcels with rip rap rather than rip rap removal. Overall, the changes in rip rap and seawall of Rock Lake between surveys are essentially negligible.

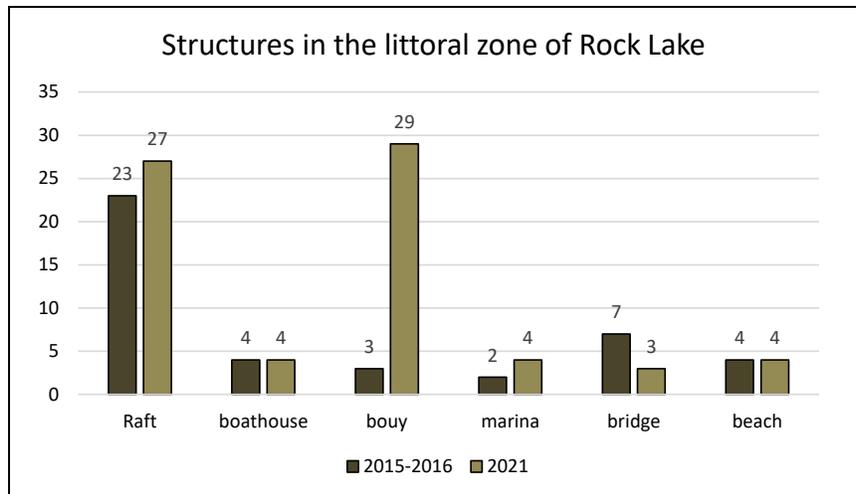
Figure 2c: Number of various human structures in found in the littoral zone of Rock Lake during the 2015-2016 and 2021 surveys.

Structures and human influence in the littoral zone is counted. The littoral zone is the nearshore area of the lake from the ordinary high water mark out to the maximum growth of plants in a lake. The structures counted in the survey include over-water boathouses, marinas, swim rafts and platforms, and generally any other human placed item. Additional items that were counted in the “other” category during the

2015-2016 survey included 6 boat launches, a dam, 1 handicap accesses fishing platform, stairs into the water, a deck hanging over the water, and a wooden landing in the water. During the 2021 survey a couple new items were counted including paddlecraft tied to piers or shore and a trampoline that was placed in the lake next to a pier. Most of the items in the littoral zone remained the same or very similar between surveys with the exception of mooring buoys. It is thought that the mooring buoys associated with lots may have been undercounted during the 2015-2016 survey because sometimes the survey boat was in between the shore and the buoy, and the surveyors were looking at the land. It does appear though that there was a large increase in the presence of mooring buoys in the five years between surveys. This could be because of low water levels and lake users having difficulty accessing their piers by boats and so needing to moor further out. Another possibility that several lakefront property owners have mentioned is that many people were doing so because they have experienced motorboats driving at high speeds too close for comfort while swimming off their pier and the buoys kept them further away from shore.

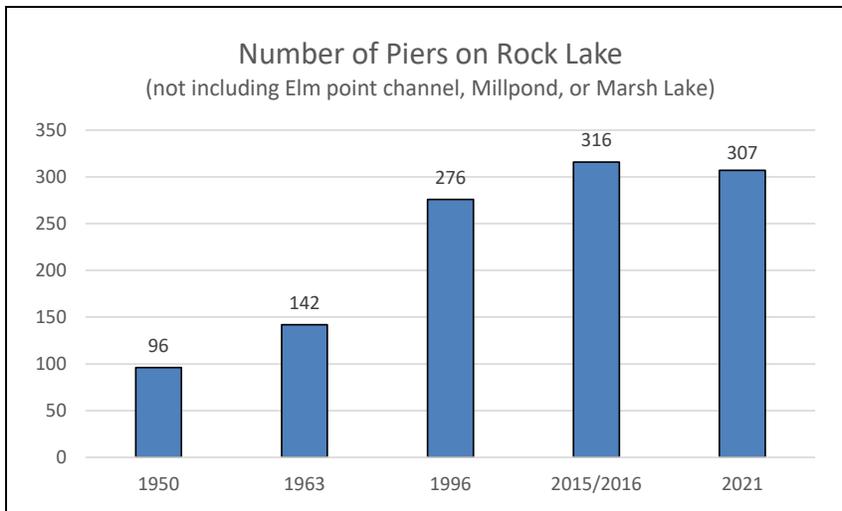
Figure 2d: Number of piers on Rock Lake through the years.

The 1950 and 1963 data were generated by the Wisconsin Department of Natural Resources (DNR) via mid-summer aerial photos. The DNR also did a pier survey by boat in 1996. These 3 surveys didn’t include piers in the millpond, Marsh Lake, or the channel located along Elm Point Road. The number of piers displayed in the chart for 2015/2016 and 2021 includes the piers

Throughout the years, there have been surveys of piers on Rock Lake. This number is important because it gives an indication of the development of the near-shore water area. The information is contained in figure 2d. Piers and similar structures have both a site specific and

counted on Rock Lake during the shoreline habitat assessment but not the Marsh, millpond, or Elm Point channel for comparison sake (although these were counted as part of the survey). The number of piers documented in 2015 and 2016 in the Elm Point channel was 3 and in the millpond was 13. In the 2021 survey 5 piers were counted in the Elm point channel and 13 in the millpond. Properties that don’t have piers in the Elm Point channel typically still had boats parked along their frontage, there were 9 watercraft counted in the water during the 2015/2016 survey in the Elm Point channel. During the 2021 survey it was observed that the Elm Point channel opening was very shallow and difficult to navigate. While it has probably experienced some sedimentation over time this was probably

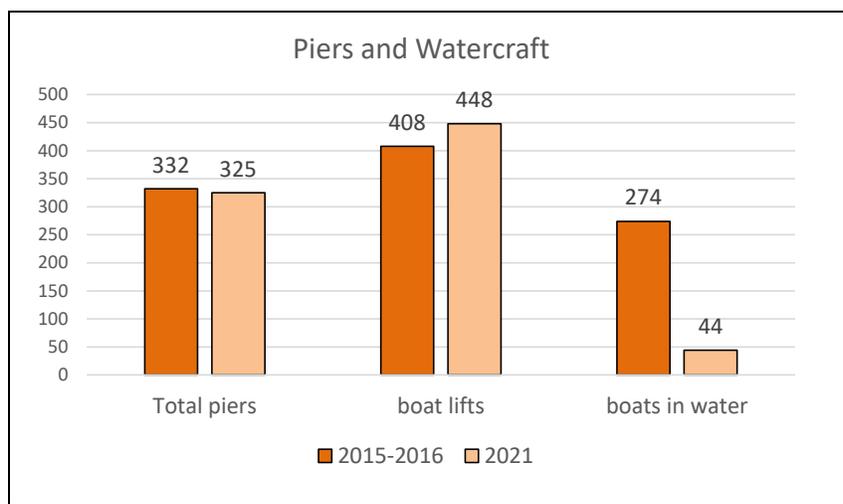
Figure 2e: Counts of total pier, boat lifts, and boats observed in the water for both the 2015-2016 and 2021 surveys.

exacerbated by the record low water levels in 2021. During the 2021 survey while there were two additional piers counted, there were only 3 watercraft in the water. In 2015/2016, the total number of piers on Rock Lake including the millpond, and the Elm Point channel was 332, in 2021 it was 325.

Both watercraft in the water and boat lifts were counted to obtain an approximation of the number of watercraft (boats, sail boats, jet skis, etc.) kept on the lake. However, it should be noted that empty lifts were counted and some of the watercraft in the water could typically be “housed” on those empty lifts. In addition, some watercraft typically kept at the pier in the water (or on a lift) could have been in use on the lake and therefore would not have been counted as part of the survey. The metric would not be a good indication of the amount of recreation taking place on the lake.
